OTHER ENVIRONMENTAL INFORMATION

Copy of Phase 1 Environmental Site Assessment and Asbestos Sampling Report

Re: Home Depot

V. HUNTINGTON BEACH, CALIFORNIA

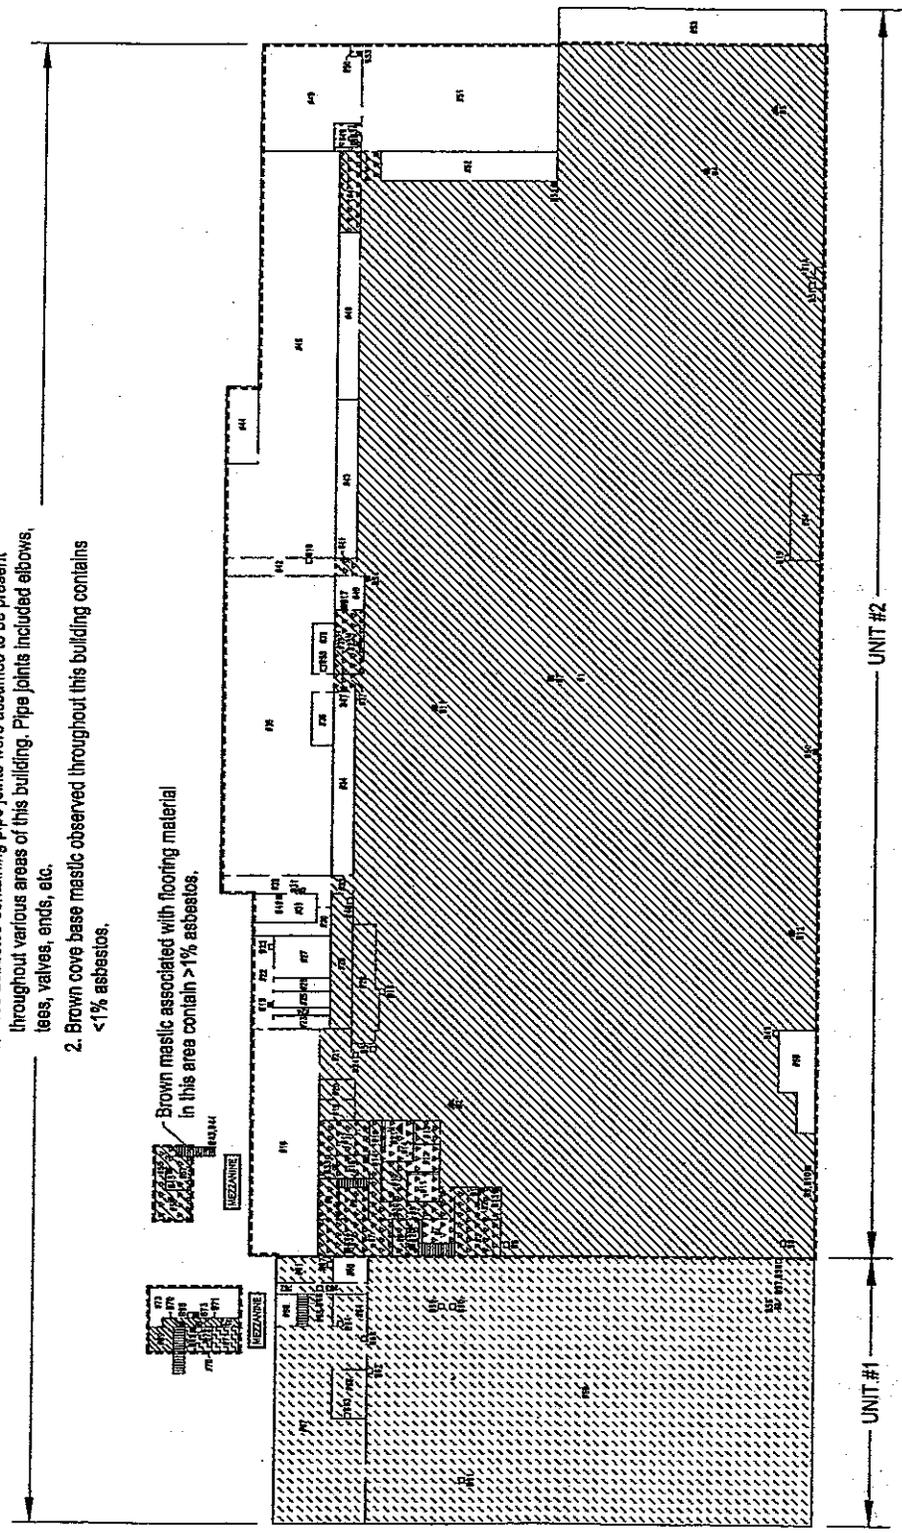
PROJECT NO. C01-490C FIGURE 2

1. <100 asbestos-containing pipe joints were assumed to be present throughout various areas of this building. Pipe joints included elbows, tees, valves, ends, etc.
2. Brown cove base mastic observed throughout this building contains <1% asbestos.

Brown mastic associated with flooring material in this area contain >1% asbestos.

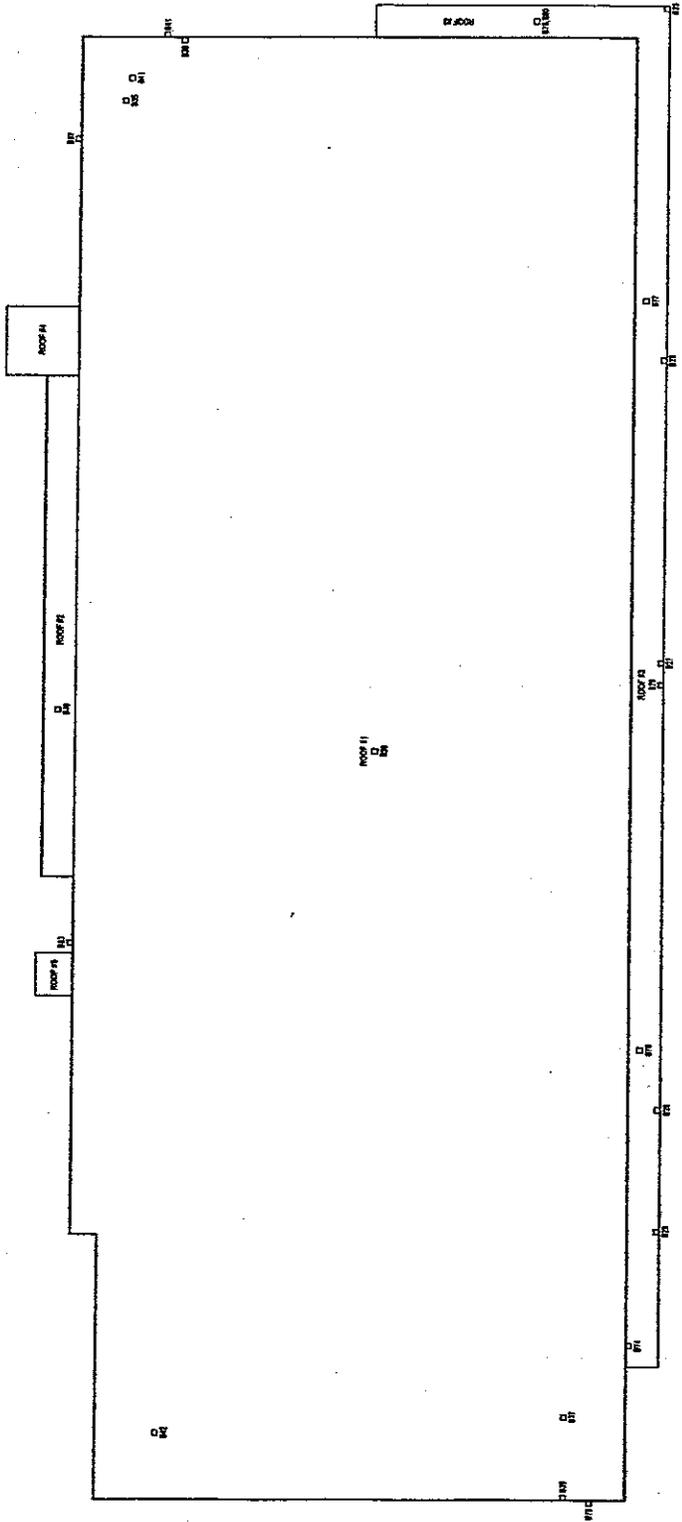
NO ACM DETECTED ON THE ROOF AND EXTERIOR OF THIS BUILDING
